STRUCTURAL DIAGNOSTICS AND MONITORING OF CULTURAL HERITAGE

KEYWORDS: historic structures, marble statues, NDT, cracks, sensors, monitoring

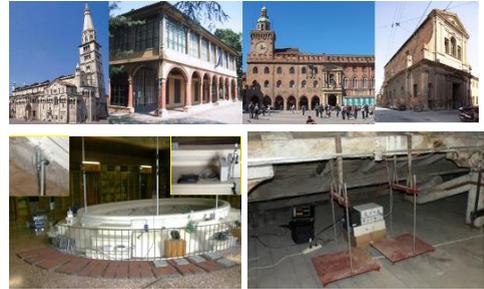
Fig. 1. Some structures recently surveyed: Ghirlandina tower and Modena Cathedral (UNESCO sites), Palazzina della Viola, Palazzo D'Accursio, San Barbaziano church (top); Palazzo Malvezzi, load tests on a ceiling, with details of traditional and wireless monitoring systems, and on a timber beam (bottom) (Colla).

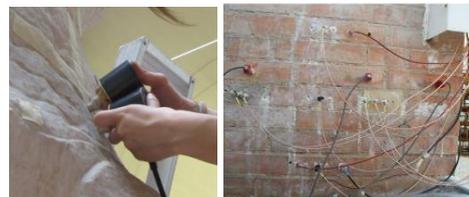
Fig. 3. Ultrasound tests at the David and wireless monitoring of salt content in masonry (Colla).
